## Lakes of Woodtrace *Pinehurst, TX*

Report #: 43707-0  
Beginning: January 1, 2023  
Expires: December 31, 2023

# RESERVE STUDY "Full"

September 2, 2022

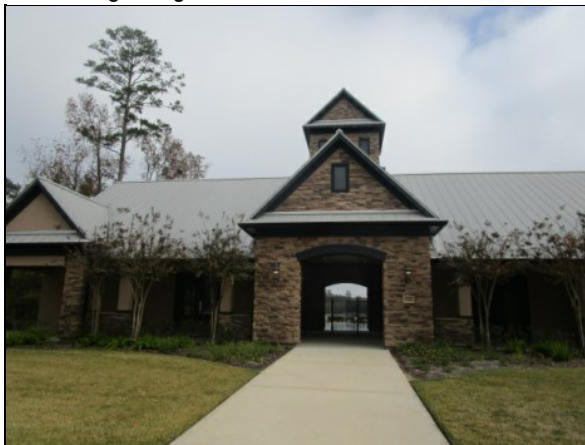
Association Reserves does not specifically endorse any products, manufacturers or vendors, but James Hardie Building Products, Inc. is the leading manufacturer of fiber cement siding, and their website ([www.jameshardie.com](http://www.jameshardie.com)) is an informative resource for proper care and maintenance of fiber cement siding. Their "Best Practices" guidelines offer specific guidelines for materials to be used; we strongly recommend complying with recommendations specific to your geographical area. We recommend that the Association consult with qualified exterior painting/waterproofing consultants and/or contractors to ensure that proper materials are used in painting and sealing the building siding.

Useful Life:  
60 yearsRemaining Life:  
53 years

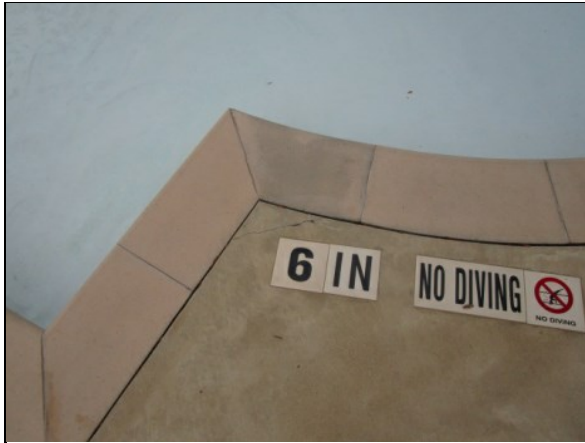
Comments: Pool coping is generally a long life component that will require minimal maintenance over the years. Pool coping materials and costs can vary, but it is appropriate to fund for eventual replacement of the coping surfaces. Coping areas can develop cracks, which can lift and cause trip hazards. The typical concrete composed materials can often get stained and discolored over time so funding for periodic replacements ensure that aesthetics are met at the pool area. Timing for completion of this project should occur in coordination with every other pool replastering project unless specified here.

Useful Life:  
20 yearsRemaining Life:  
13 years
