## Lakes of Woodtrace *Pinehurst, TX*

Report #: 43707-0  
Beginning: January 1, 2023  
Expires: December 31, 2023

# RESERVE STUDY "Full"

September 2, 2022

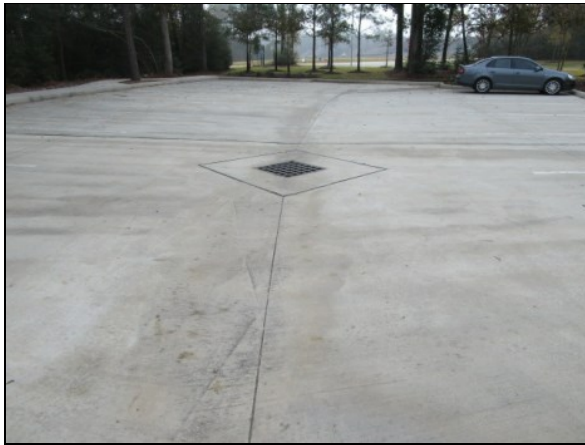
**Comp #: 206 Concrete Parking - Repair 15%****Quantity: ~ 5,250 GSF**

Comments: Funding provided to repair 15% or 788 GSF of the total surface area.

Concrete parking areas determined to be in fair condition typically may exhibit small changes in slope and narrow "hair-line" wide cracks. Overall, no unusual or extreme signs of age noted.

All areas should be inspected periodically to identify potential trip hazards or other safety issues. Concrete maintenance typically consists of pressure washing, crack repairs, and replacement of small sections as-needed. Exposure to sunlight, weather, and frequent vehicle traffic can lead to larger, more frequent repairs, especially for older properties. Due to evident conditions at the time of inspection, comprehensive replacement is anticipated at the approximate timeframe below. However, we recommend that the Client consult with a qualified professional (consultant, contractor, or engineer) to determine potential replacement timelines and cost estimates. This component should then be re-evaluated during future Reserve Study updates and adjustments made based on the most current information available at that time.

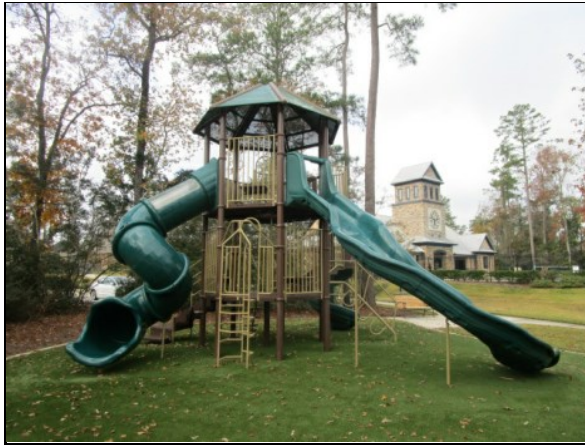
**Comp #: 405 Play Equipment - Replace****Quantity: (3) Assorted Pieces**

Playground equipment/features determined to be in good condition typically exhibit few or no significant signs of wear or age. Any moving parts appear to be functional and serviceable. Style/design is appropriate for the standards of the property.

As a routine maintenance expense, inspect for stability, damage and excessive wear and utilize maintenance funds for any repairs needed between replacement cycles. Our inspection is visual in nature only not intended to identify any structural or latent defects, safety hazards, or other liability concerns. Life expectancy can vary depending on the amount of use/abuse. Observations and replacement intervals shown below are strictly for budget purposes. Unless otherwise noted, cost estimates assume replacement would be with comparable size and style of equipment as noted during inspection.

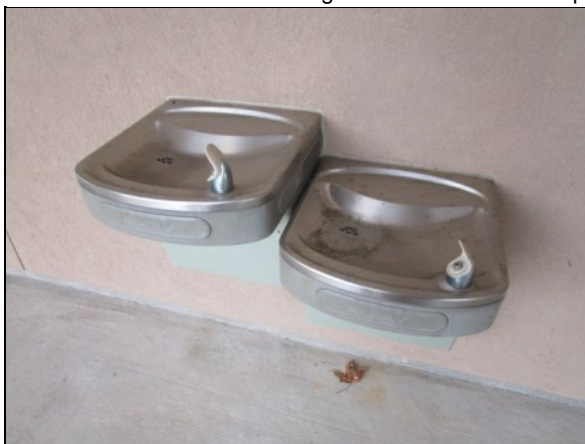
**Comp #: 411 Drinking Fountains - Replace****Quantity: (2) Drinking Fountains**

Comments: The drinking fountains are in fair condition. No damage or corrosion noted. Expect a full useful life.

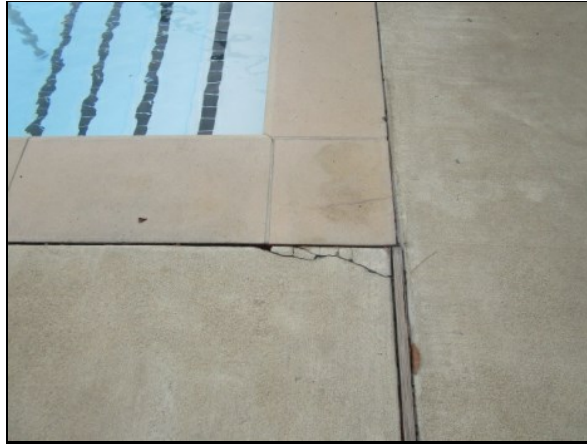
**Comp #: 1200 Pool Deck – Repair 20%****Quantity: ~ 6,950 GSF**

Comments: Funding provided to repair 20% or 1,390 GSF of the total surface area.

Pool decking is in good condition. Minor cracking observed at this time. Funding provided for periodic repairs and replacements. Best to re-evaluate during future updates.

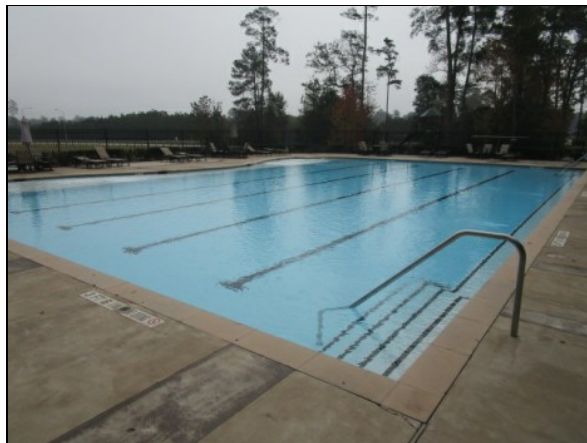
Comments: Swimming pools determined to be in fair condition typically exhibit some color fade/discoloration, and roughening of the surface, often more noticeable in the shallow areas and/or at steps. Waterline tiles are in fair condition. Generally believed to be aging normally.

Minor repairs and routine cleaning/maintenance should be considered an Operating expense. Pool resurfacing will restore the aesthetic quality of the pool while protecting the actual concrete shell of the pool from deterioration. This type of project is best suited for slow/offseason to minimize downtime during periods when pool is used heavily. Should be expected at the approximate interval shown below; in some cases, schedule may need to be accelerated due to improper chemical balances or aesthetic preferences of the Client. While drained for resurfacing, any other repairs to lighting, handrails, stairs, ladders, etc. should be conducted as needed.

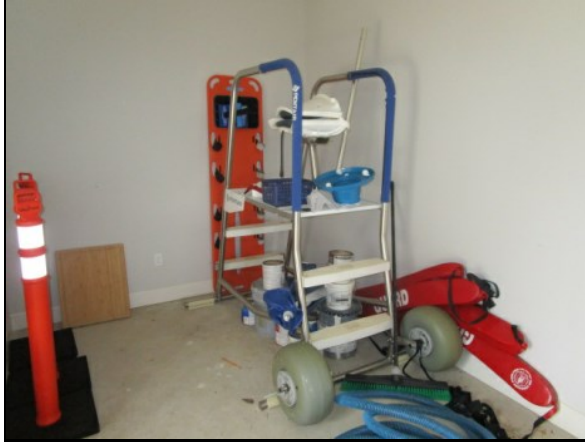
**Comp #: 1211 Lifeguard Stand - Replace****Quantity: (1) Lifeguard Stand**

Comments: The lifeguard stands are intact and in good condition at this time. No areas of damage or premature deterioration. Inspect on a regular basis in order to ensure stability. Best to replace as an operating expense.

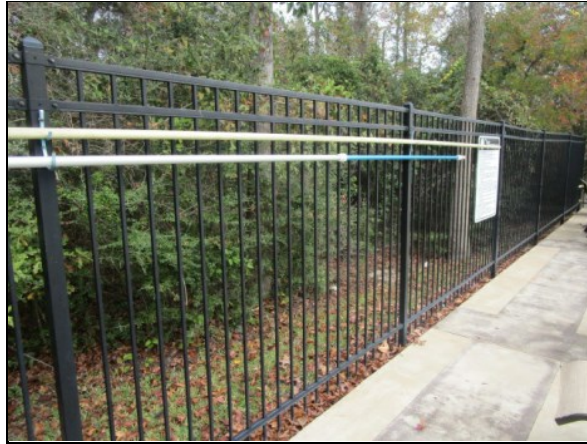
**Comp #: 1225 Pool Fence - Replace**

Comments: Pool fencing determined to be in good physical condition is stable and upright, with no signs or reports of damage or required repairs. All components and hardware appear to be in serviceable condition with no unusual or advanced signs of wear or age. Fencing is in good aesthetic condition.

We recommend that the Client periodically clean fencing with an appropriate cleaner and touch up paint as needed in between regular paint cycles. Gates and locks should be inspected to make sure they close and lock properly as a faulty perimeter around a pool area can expose a Client to significant liability risk. As a routine maintenance item, fence should be inspected regularly and repaired as needed through the Operating budget to ensure safety. When evaluating replacements, be sure to comply with any applicable building codes. When possible, replacement should be coordinated with other projects, such as pool deck projects, other fencing/railing work, etc. Based on evident conditions, aesthetic standard considerations, and/or Client history provided during this engagement, we recommend replacement at the approximate interval shown below. Unless otherwise noted, cost estimates below assume replacement with a similar material/height as currently in place.
